# Revised Work Plan (RWP) for Additional Characterization of Extent of RIM in Areas 1 and 2 West Lake Landfill Operable Unit-1, Bridgeton, Missouri

WESTLAKE LANDFILL PHOTO DOCUMENTATION OU1 10.20.2015

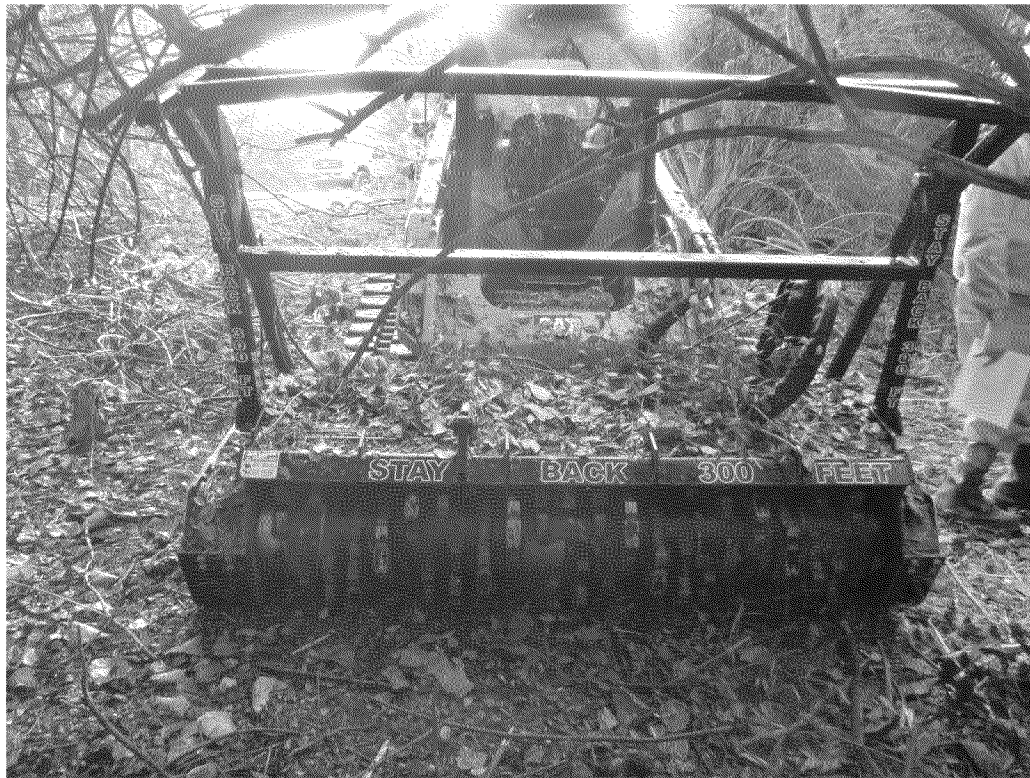
The view is facing southeast and shows what the forestry mower / cutter attachment on the bobcat looks like. The forestry mower is used to cut small trees and brush in preparation for grading a pathway through the site for the additional testing and characterization.

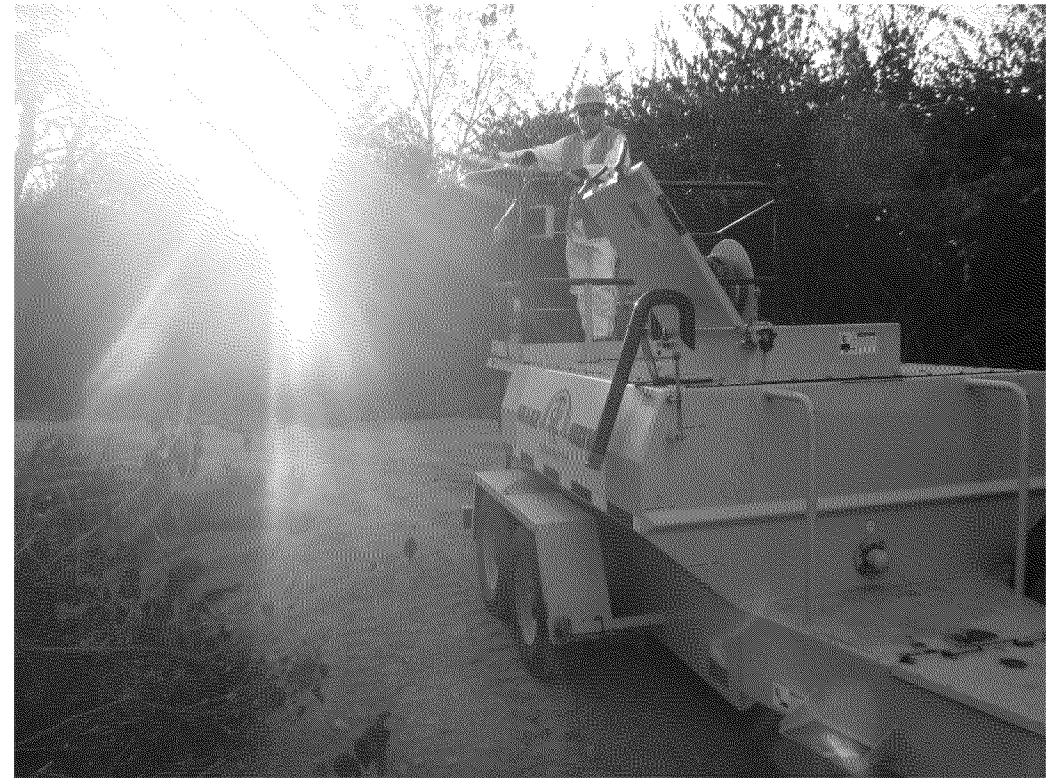
The view is facing south and shows what the water truck looks like. The water truck provides water for the dust suppression mister/hose being used inside the OU1 area.

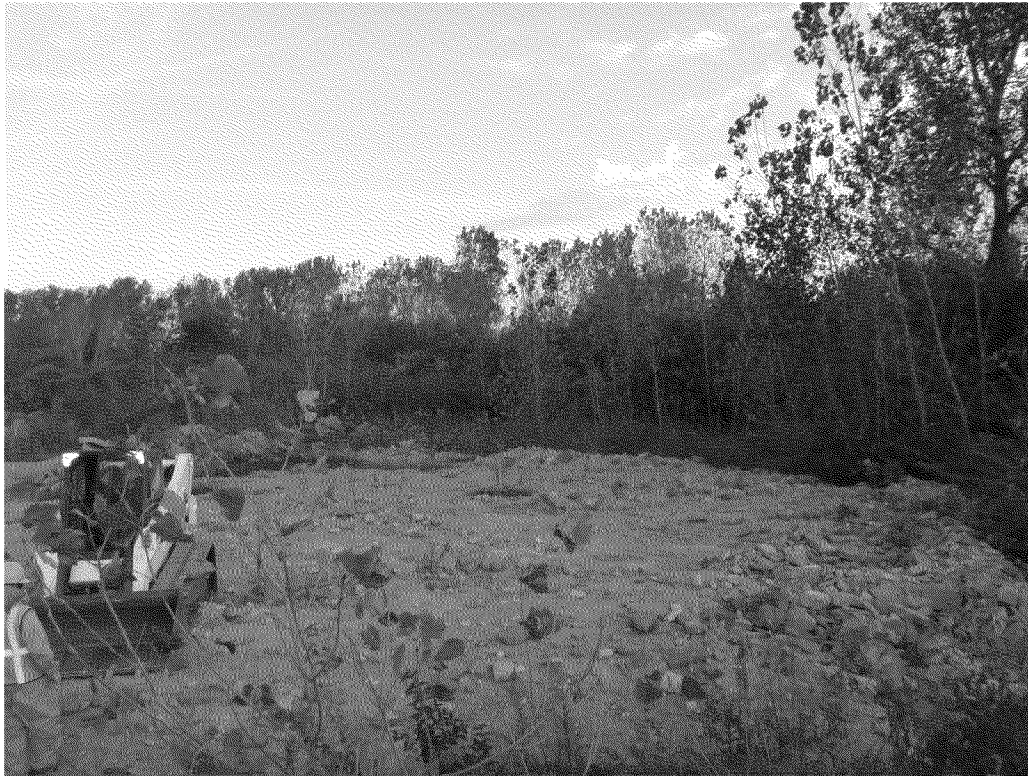
Photo taken near reference area 16, inside OU1 area, the view is facing northeast.
